PUGET SOUND PILOTS
Protecting Puget Sound Since 1935

Pilot Transfer Arrangement Safety Newsletter

June 2023

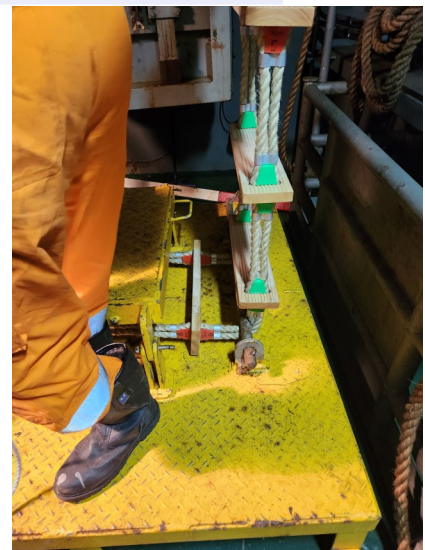
Vessel Name: SEAMAX Mystic

Non-Compliance: Pilot Ladder Side Pilot Port Ladder Winch Reel

Pilot Ladder: Weight of ladder rests on step/spreader due to hold down device pin, railing or deck tongue 2,4,5,8,10

Side Pilot Port: Improper Rigging 3,4,8,10

Ladder Winch Reel: Improper rigging 4,5,8,10

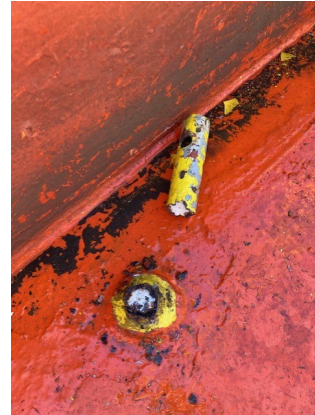
While boarding the Aries Pearl the main deck hand-hold stanchion “broke” (deteriorated) when the pilot grabbed ahold of it. Fortunately there were no injuries. This is a reminder that just about anything can fail, even the most unlikely parts of the Pilot Transfer Arrangement. This was shared with PSP from the Hawaii Pilots and another example of how all WC Pilot groups are working together to increase pilot safety.

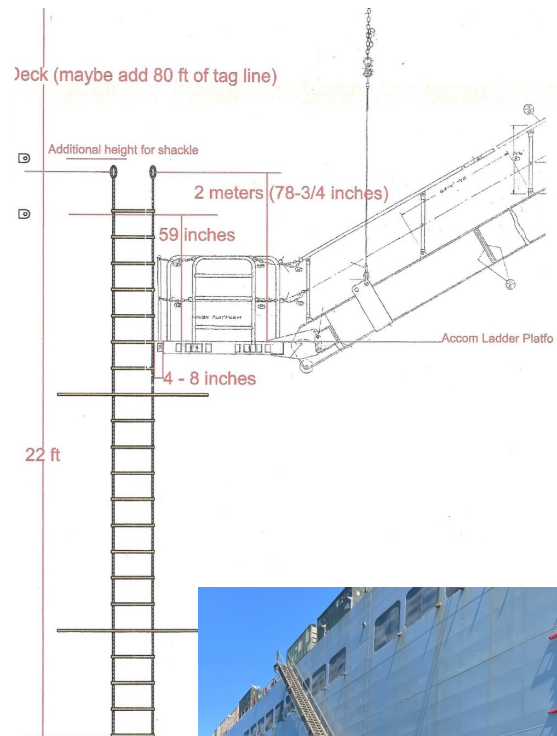
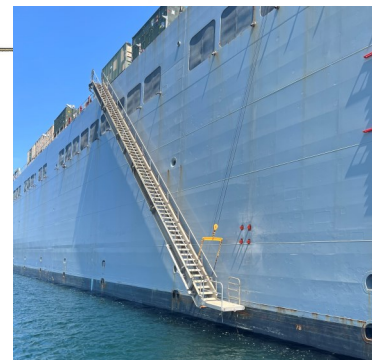
The USNS Fisher and USNS Bob Hope arrived in Puget Sound mid May with known non-compliant trap door arrangements.

After a well intended but failed modification while in PS on the USNS Fisher which was approved by ABS (attached photo), the APA, MSC and MARAD have all become involved. Capt Bendixen visited the USNS Fisher and had a thorough in person conversation with the Capt and email correspondence with their port engineer. PSP provided additional tech-

After mod: Not 5m above water!

Additional information was shared to the vessel on how to resolve the known issue for this class of vessel. The USNS Bob Hope, which has been a regular caller in PS provided technical drawings to resolve the issues and we were able to provide those to the USNS Fisher.

nical drawings, examples of successful modifications, and pertinent regulations.
